Value-added agriculture by-products: Isolation of cellulose by thermal-mechanical extrusion methods

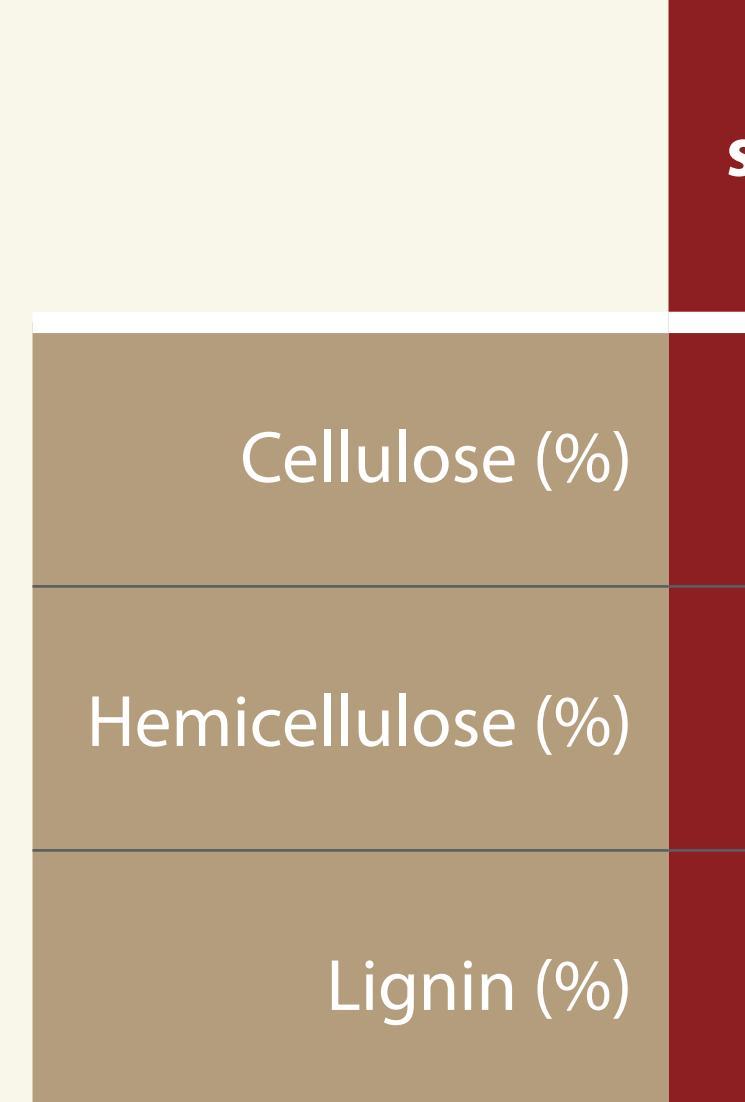
Table 1: Proportion of lignocellulosic components, unextruded vs. extruded

The concentration of cellulose did not appear to be affected by extruder conditions; however, the content of hemicellulose decreased concurrent with an increase in lignin at each process condition when compared to the raw soybean hulls (Table 1). This result would suggest that hemicellulose is susceptible to degradation by mechanical processes such as extrusion.

From unextruded raw soybean hulls and extruded soybean hulls. Extruder conditions were low temperature (LT), high temperature (HT), low speed (LS), high speed (HS).

Raw soybean hull	LT-LS	LT-HS	HT-LS
43.99	46.35	43.39	44.53
17.8	13.11	12.25	13.66
2.45	4.02	8.38	5.36

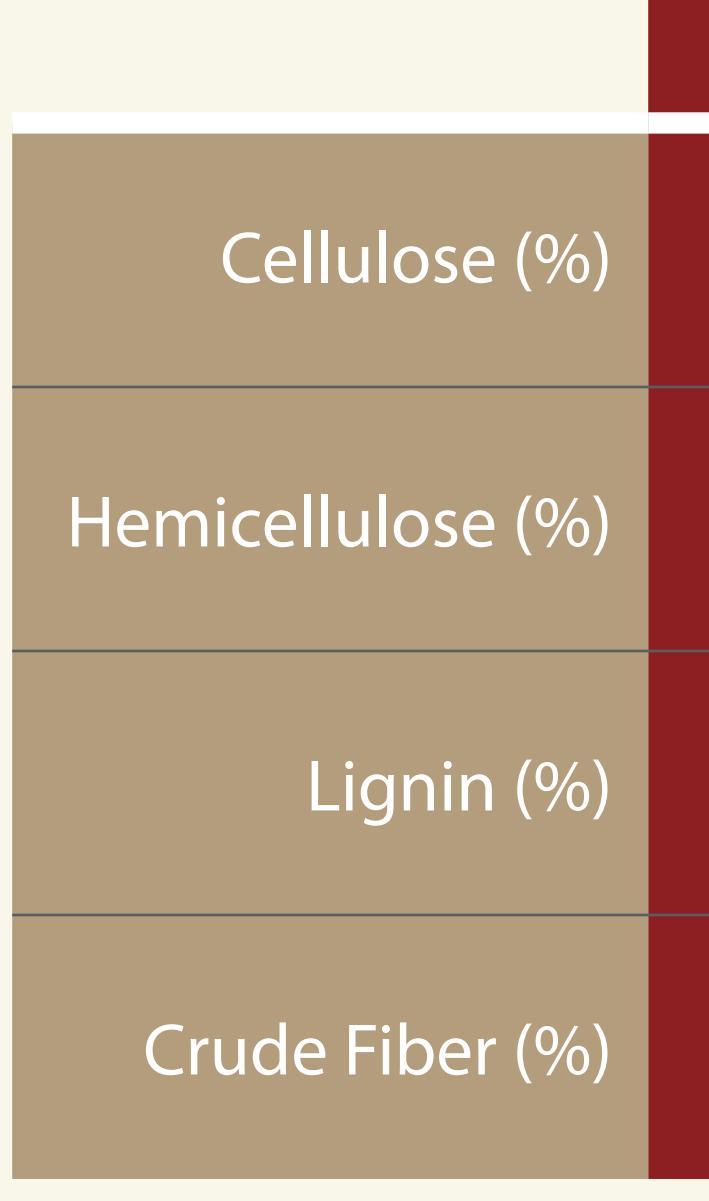
Table 2: Proportion of lignocellulosic components after chemical treatment

Following chemical treatment, we observed an increase in the cellulose content for each treatment with the largest concentration in the HT-LS treatment (Table 2). The scanning electron micrographs would further support the notion that the process has had some effect on the fibrous construct of the soybean hulls.

From extruded soybean hulls chemically treated with a 2:1 toluene ethanol mixture. Extruder conditions were low temperature (LT), high temperature (HT), low speed (LS), high speed (HS).

LT-LS	HT-LS	HT-HS
53.46	57.21	52.07
20.32	16.16	23.18
6.76	4.86	4.35
45.6	45.88	45.32

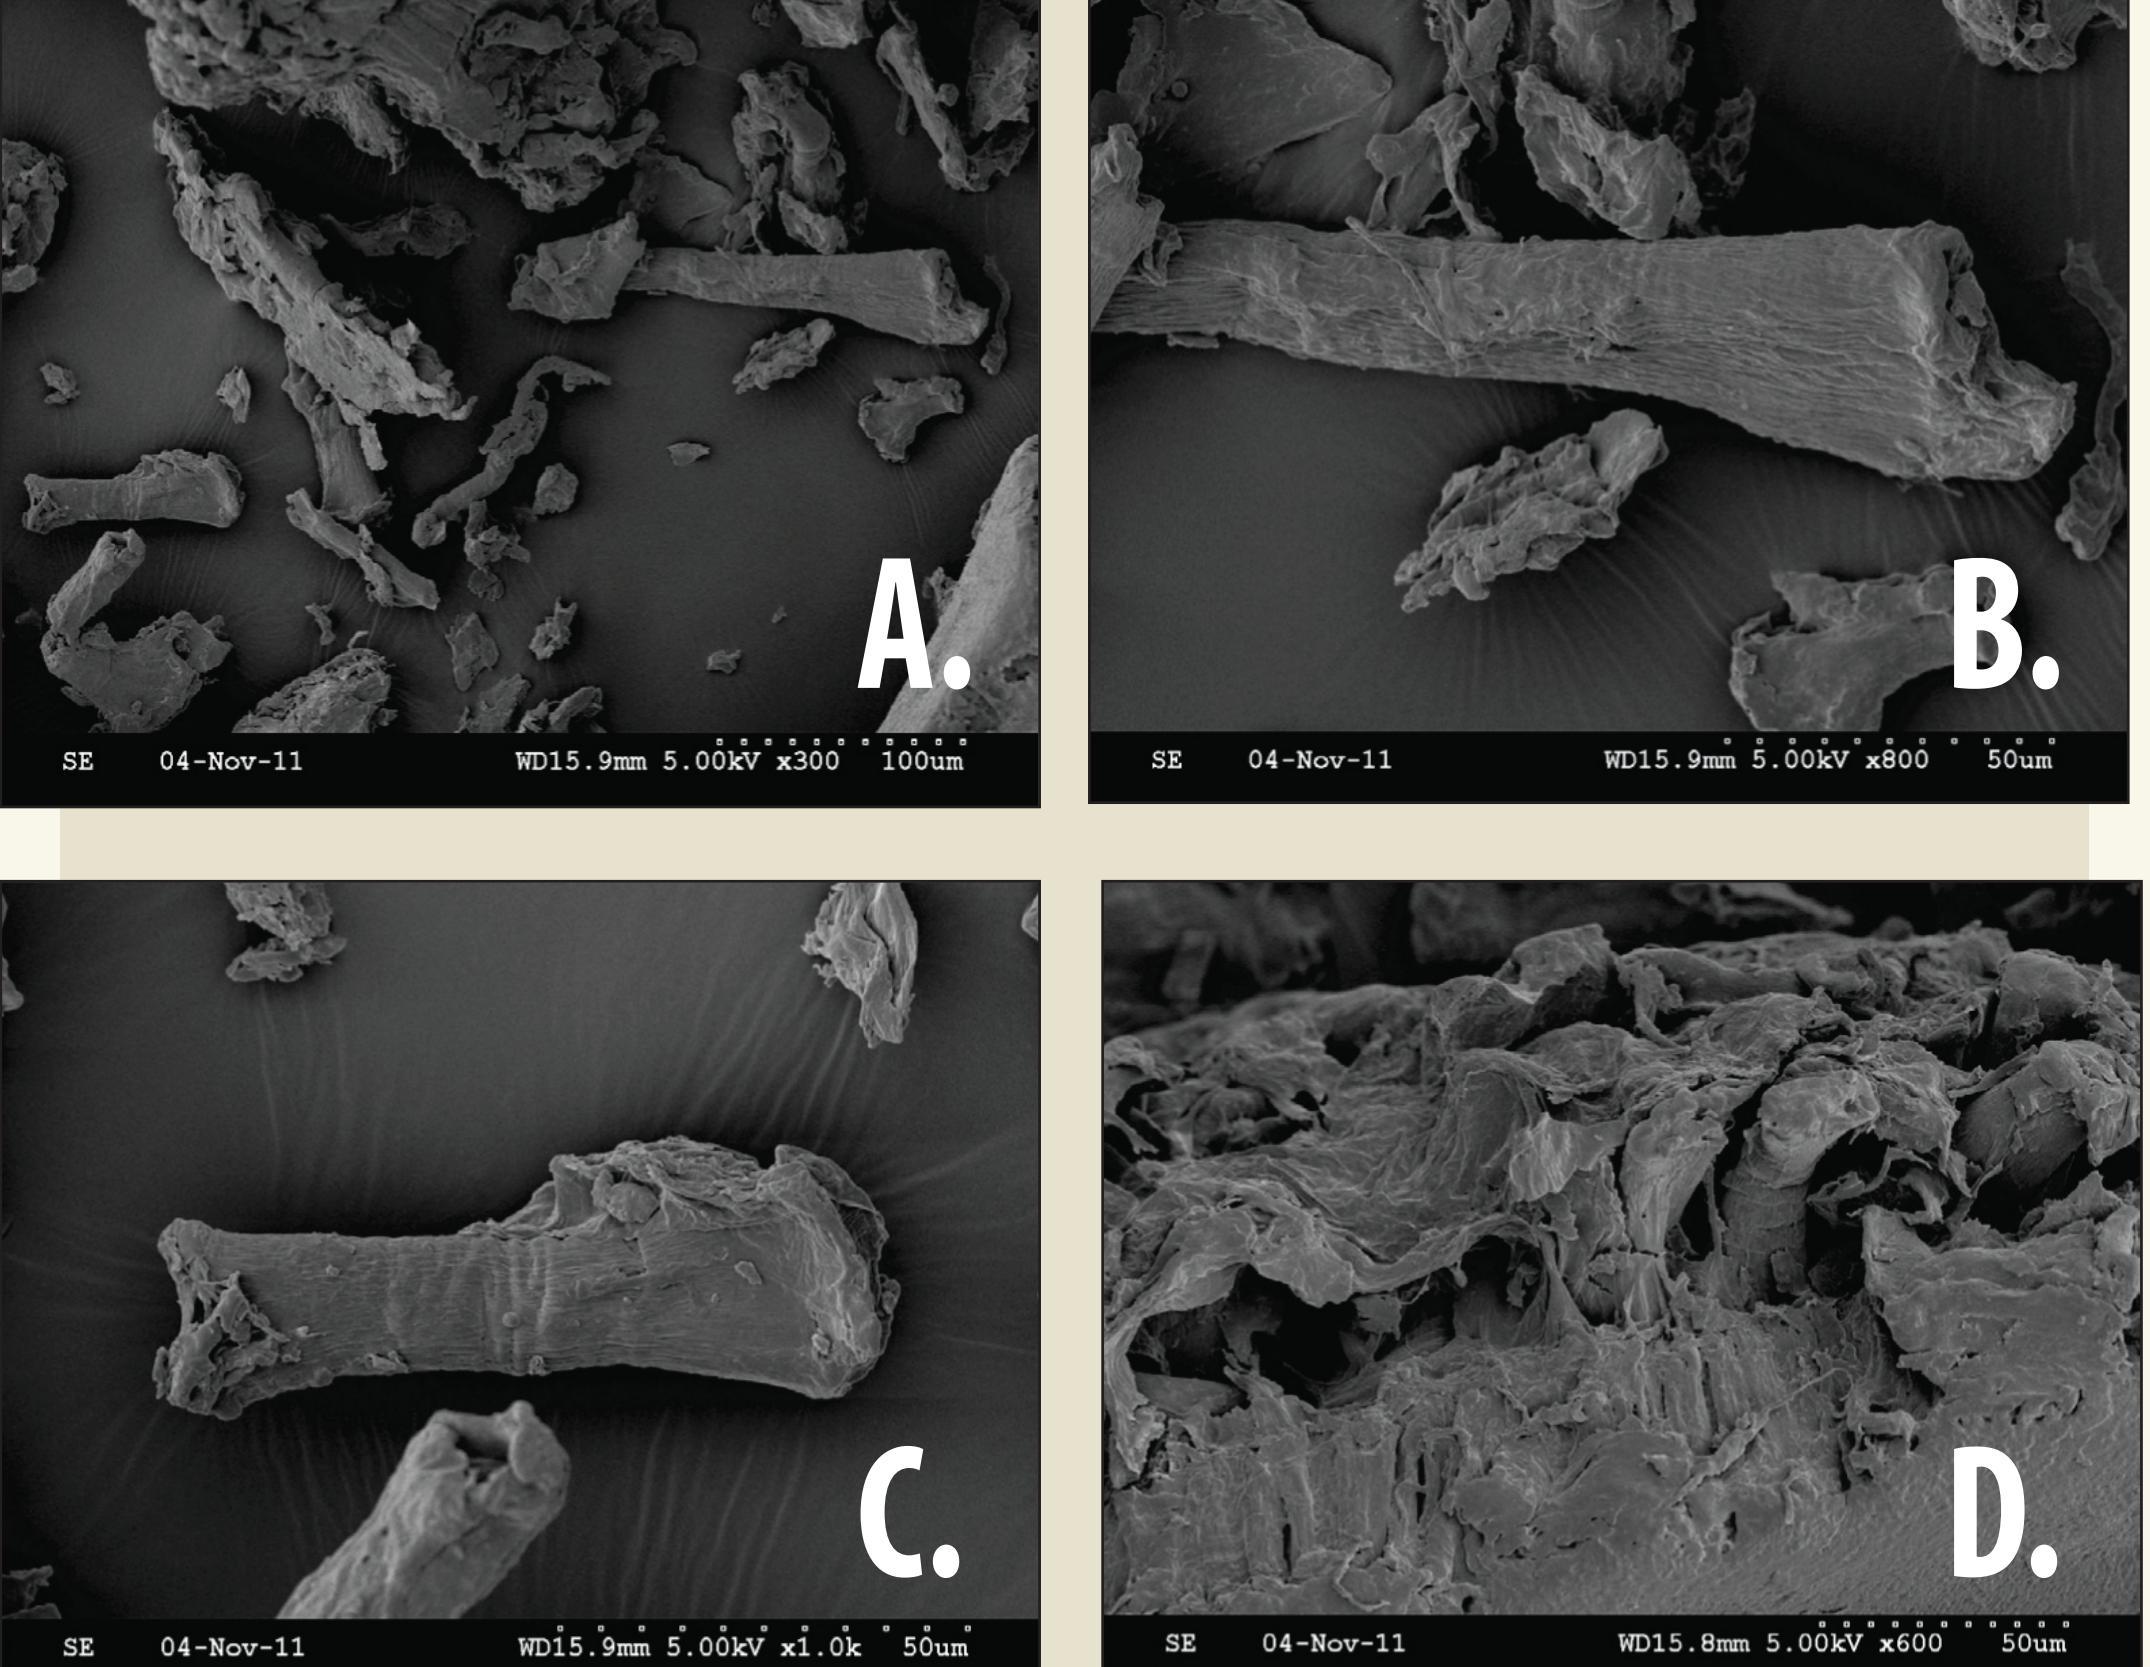
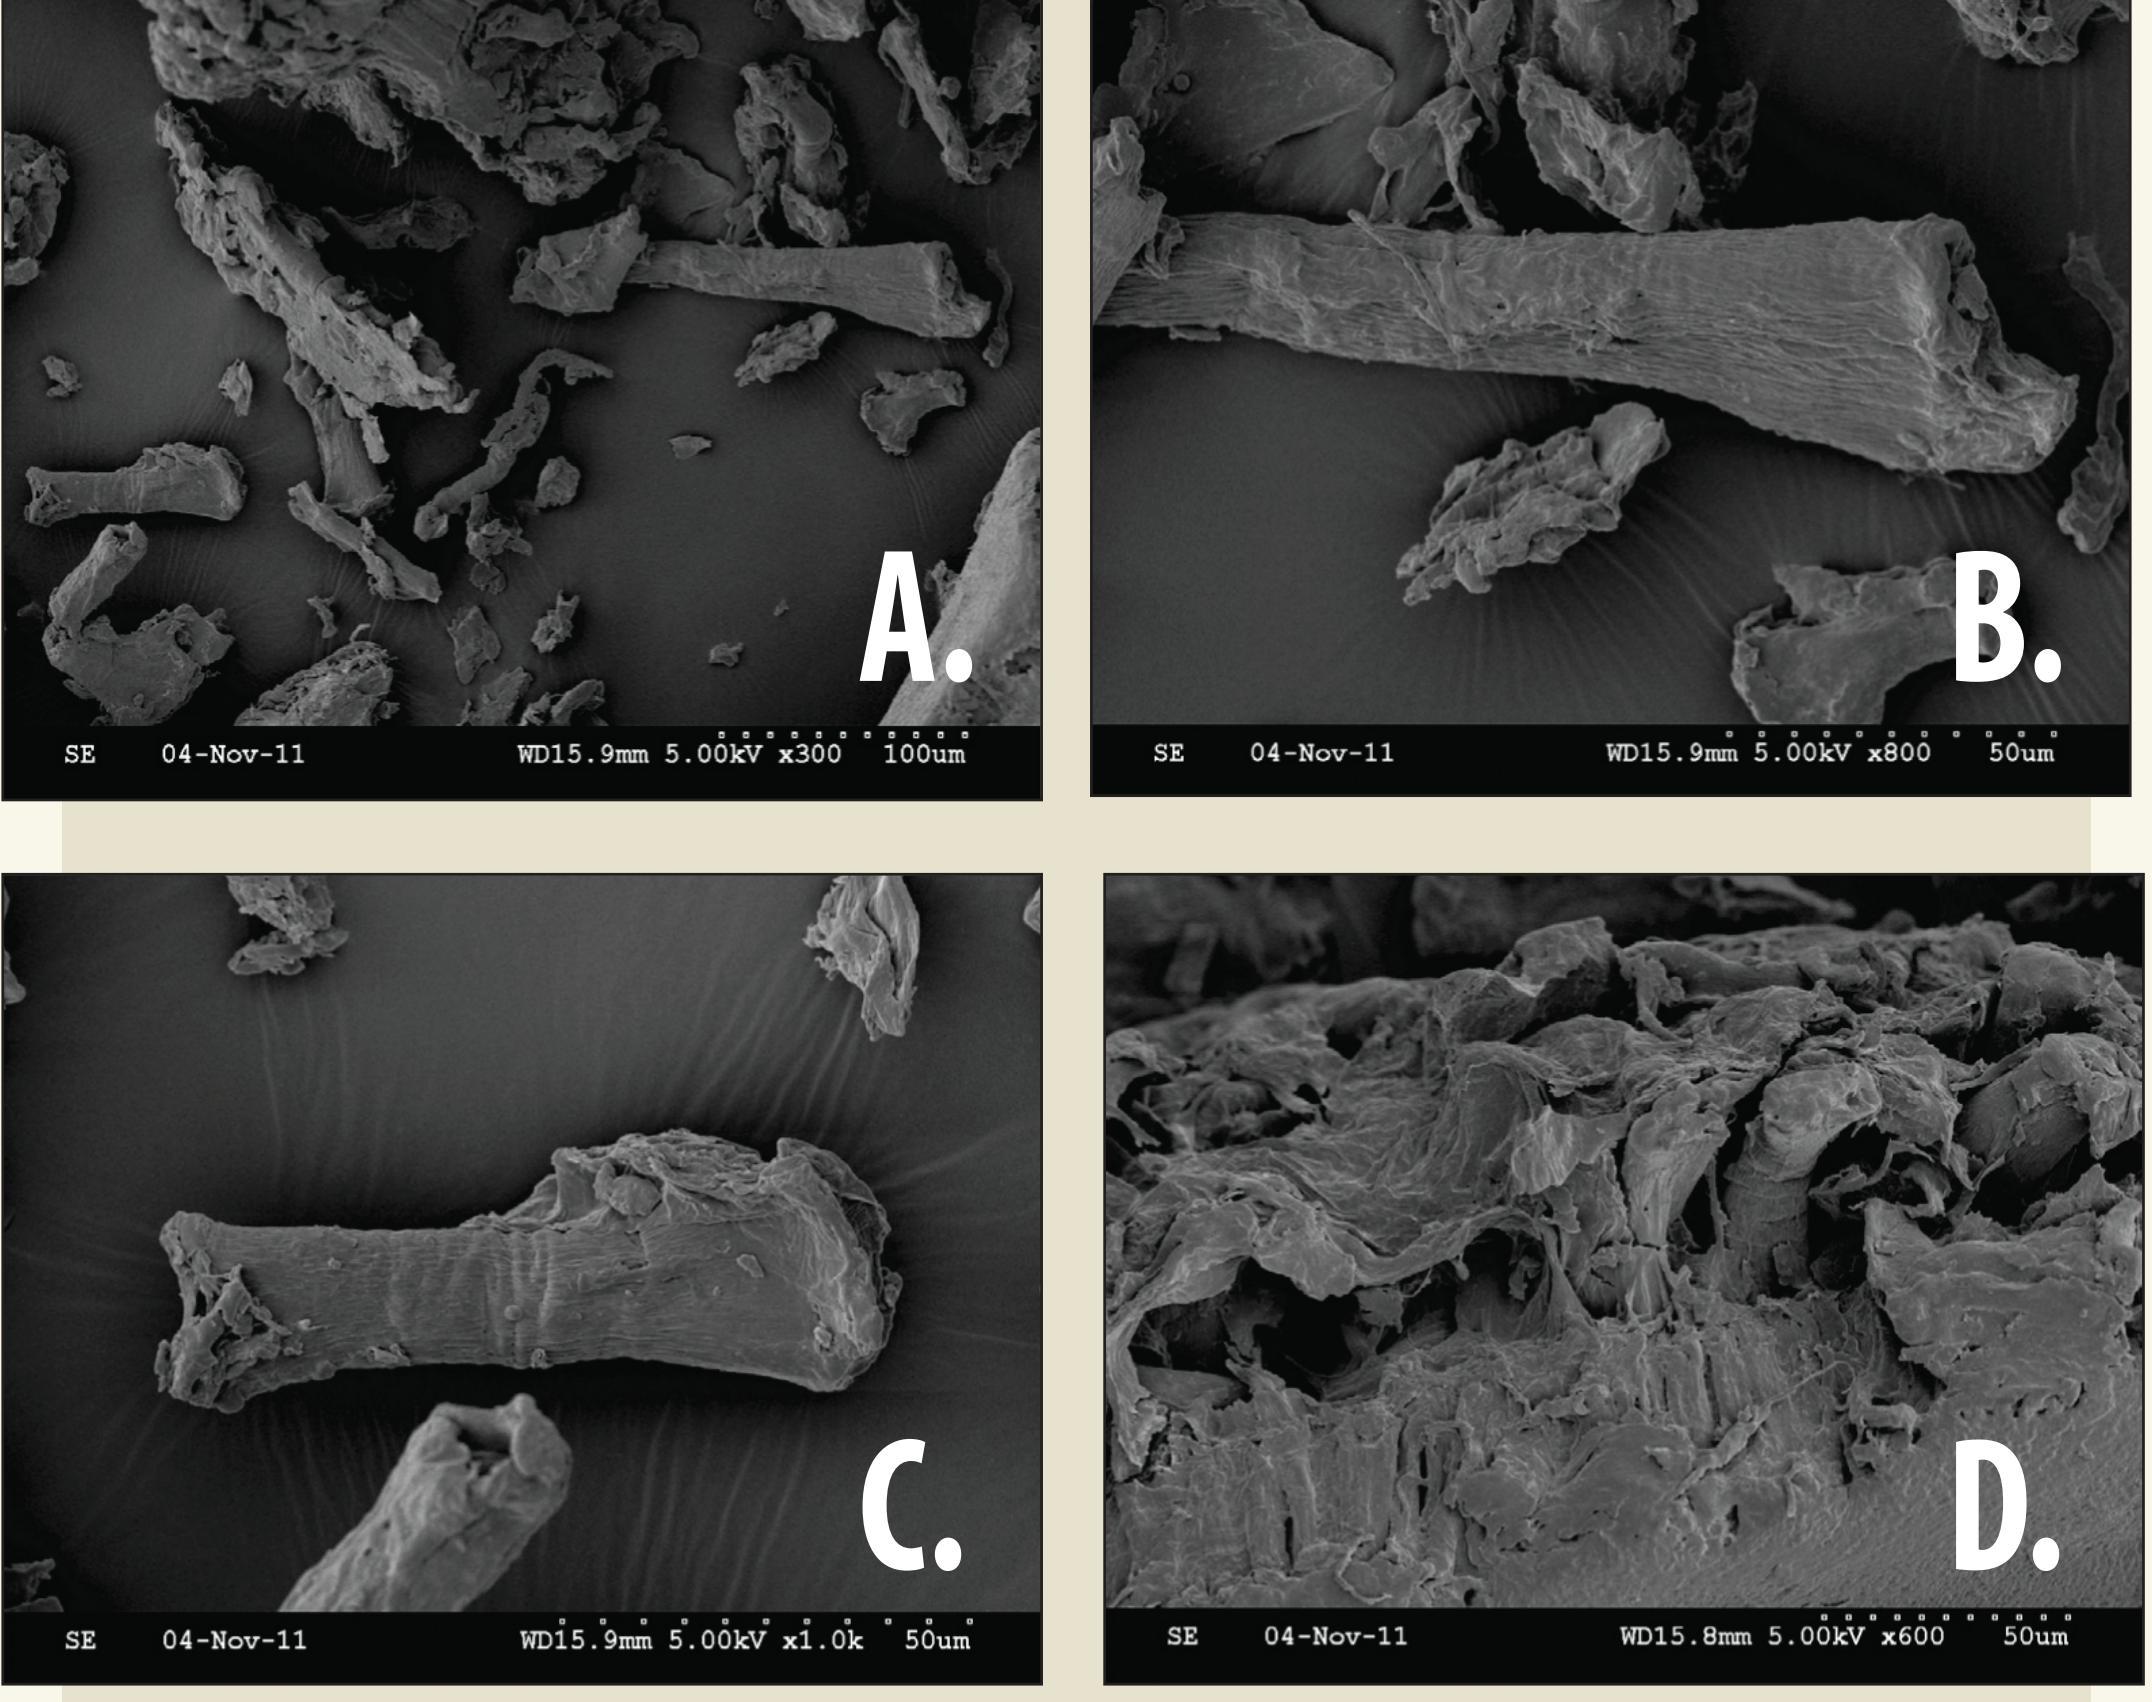
Figures A-D: SEM images of extruded soybean hulls

Scanning electron micrograph images of soybean hulls, extruded at high temperature with low screw speed.

Conclusions: We concluded that high temperature with lower screw speed visually appeared to degrade the fiber components greater based on the cellulose concentration coupled with the SEM images (Figures A-D), wherein chemical treatment post-extrusion increased cellulose concentration.
